HAMILTON

LAS VEGAS UPDATE – 7/17/15

GOALS / SUMMARY

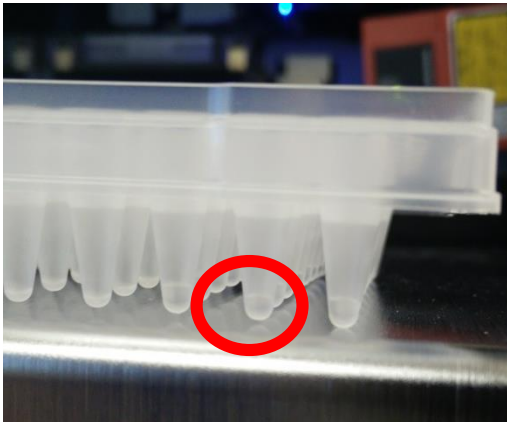
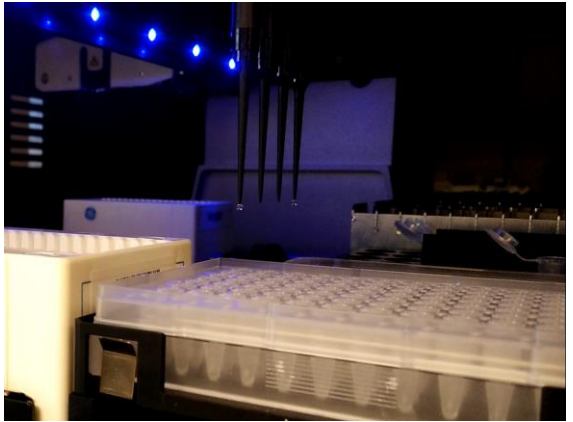
Item	Description
<p>Positive Control – Incorrect Volumes</p>	<p>[Resolved– 7.17.15]</p> <p>Problem The final volume of the positive control in the plate is incorrect, the wrong volume is being delivered.</p> <div style="display: flex; justify-content: space-around;">

</div> <p>FIGURE. (LEFT) POSITIVE CONTROL VOLUME IN A2 IS LOWER THAN IT SHOULD BE. (RIGHT) LIQUID DROPLETS ON THE TIP AFTER DISPENSE.</p> <p>Otherwise perfectly good cards were being placed into the recovery rack because the imaging software could not read the card.</p> <p>Discussion We ran a plate with 8 samples, 8 positive controls, and 8 negative controls with no allelic ladders (so each group would occupy a column and it would be easy to compare them).</p> <p>Log Files, COM Trace, and Service iData</p> <div style="display: flex; justify-content: space-around; align-items: flex-end;"> <div style="text-align: center;">

ML_STAR_6452_idat a_2015-07-17.pdf </div> </div> <p>Solution We found the positive control was being dispensed at a height of 5mm above the bottom of the PCR plate. Because this is the first dispense into those wells (the PCR mix contains the water), I changed it to dispense at 0.5mm height.</p>

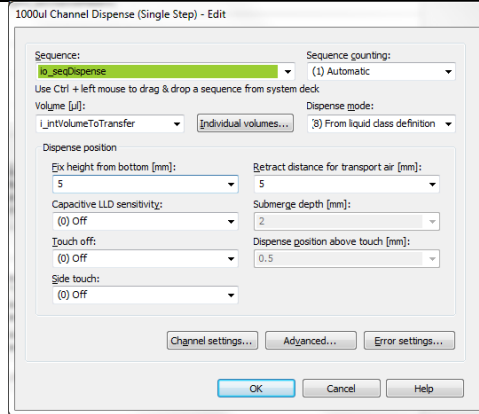
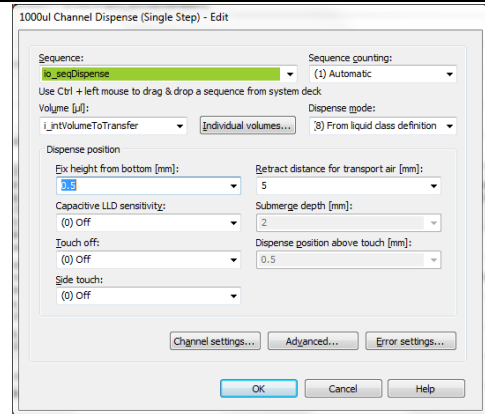
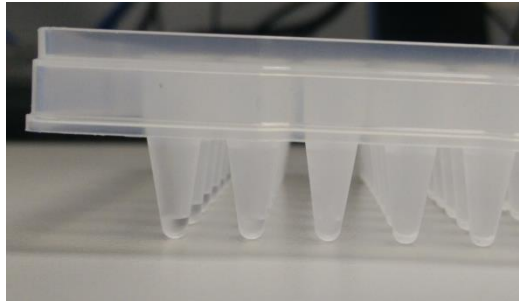
FIGURE. (LEFT) INCORRECT DISPENSE HEIGHT (RIGHT) IMPROVED DISPENSE HEIGHT
(BOTTOM) PLATE WITH CONSISTENT VOLUMES.

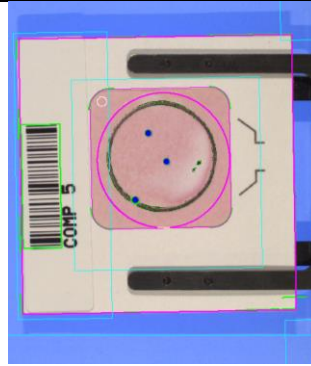
FIGURE. CONTROL 5

The imaging settings appear to not detect the sample for control card 5. Admittedly some of these cards are challenging.

Changed the card settings to use saturation instead of Hue. The last cardsettings change was 5.22.15

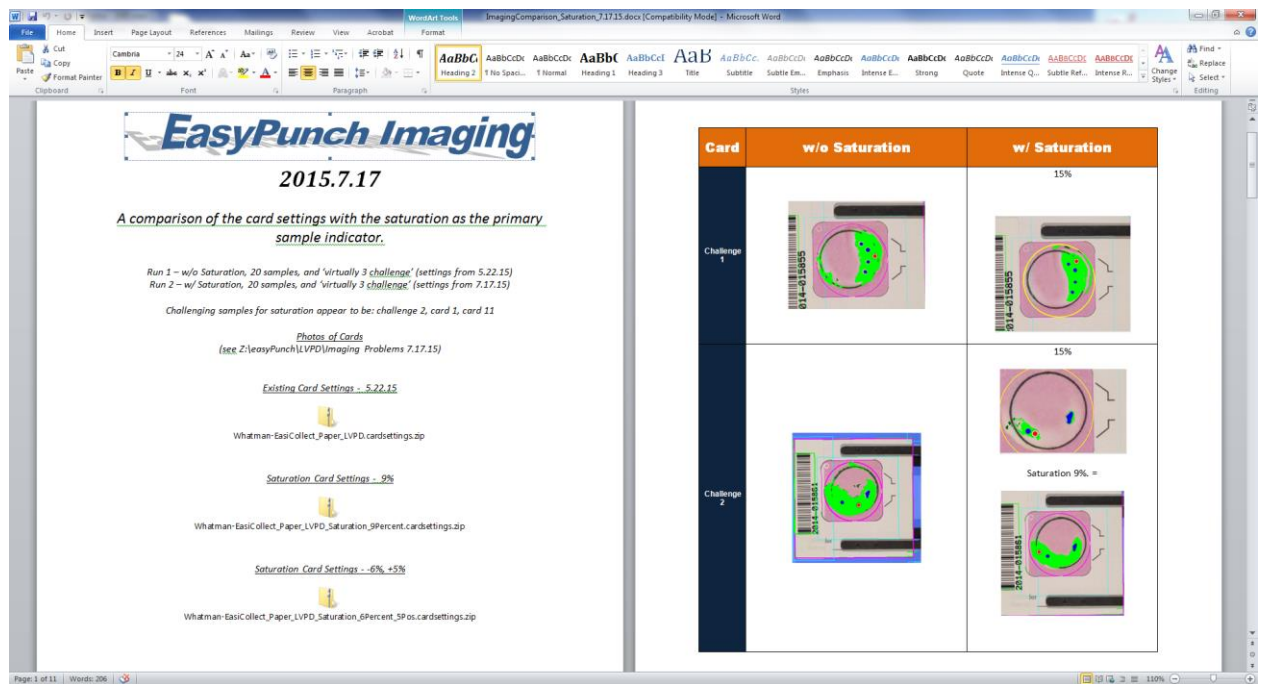
Below is a report file that contains the analysis shown above:
